RESULTS OF MONITORING OF A GIANT LANDSLIDE ON EL HIERRO ISLAND (SLOPENET)

JAN BLAHŮT,
MATT ROWBERRY, IVO BAROŇ, JAN KLIMEŠ, JAN BALEK,
STAVROS MELETLIDIS, XAVI MARTÍ

INSTITUTE OF ROCK STRUCTURE AND MECHANICS
CZECH ACADEMY OF SCIENCES

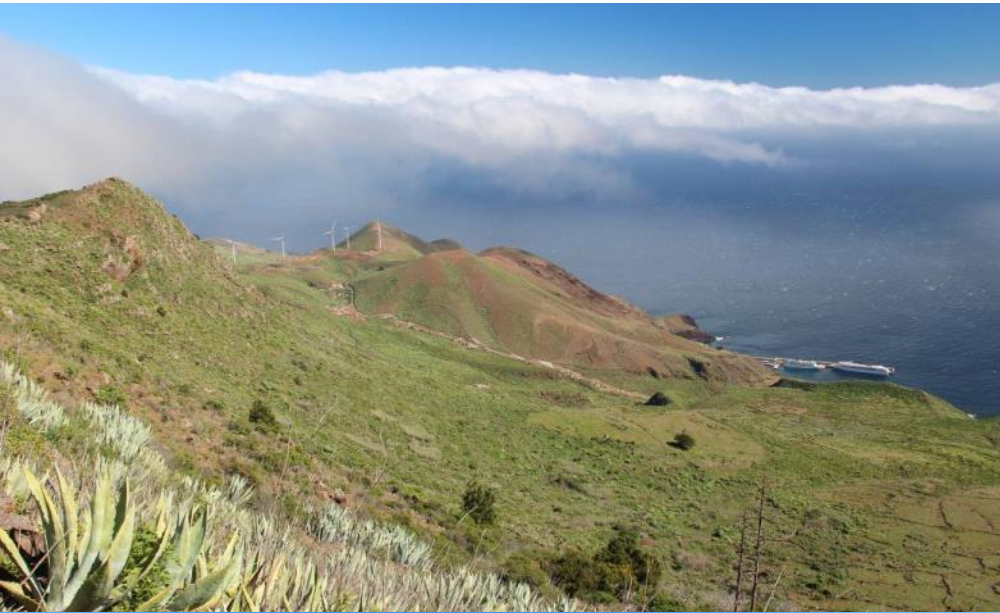
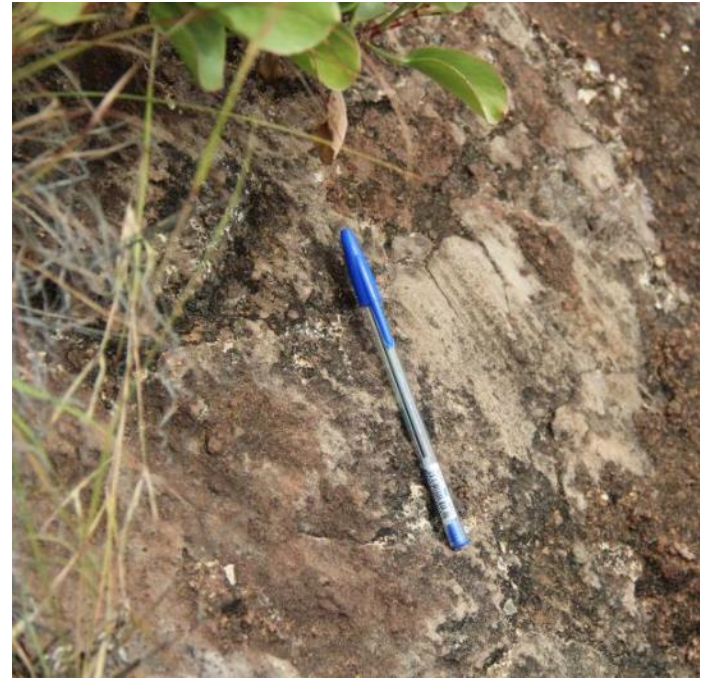
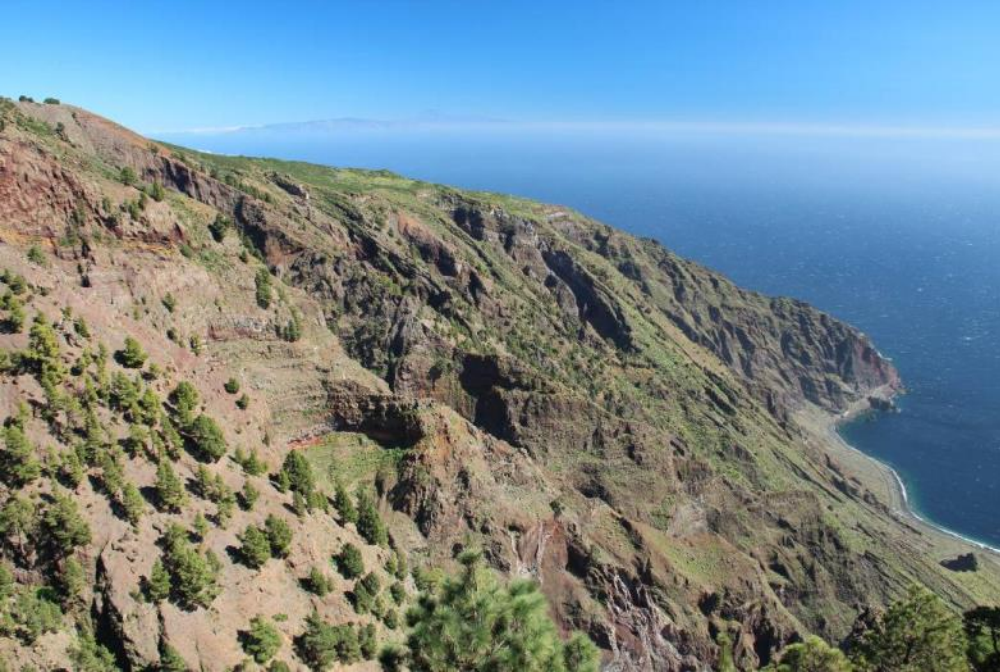
SAN ANDRÉS GIANT LANDSLIDE I

- Assumed aborted landslide of 150-250 ka
- Well developed fault system/detachment planes
- Morphologically seem still active

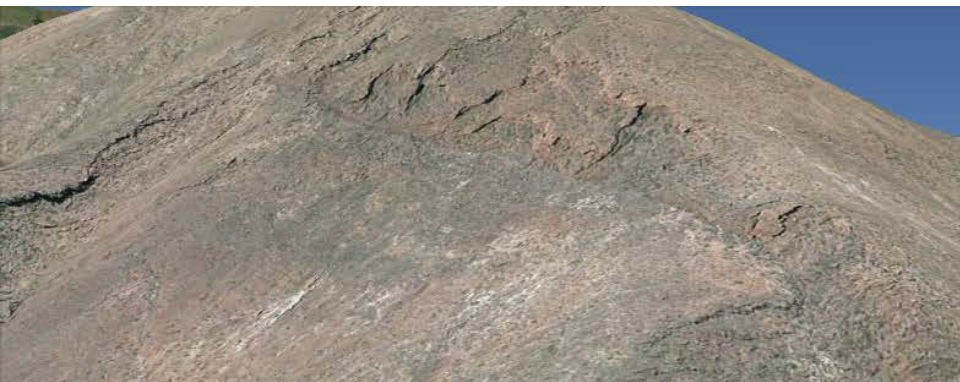
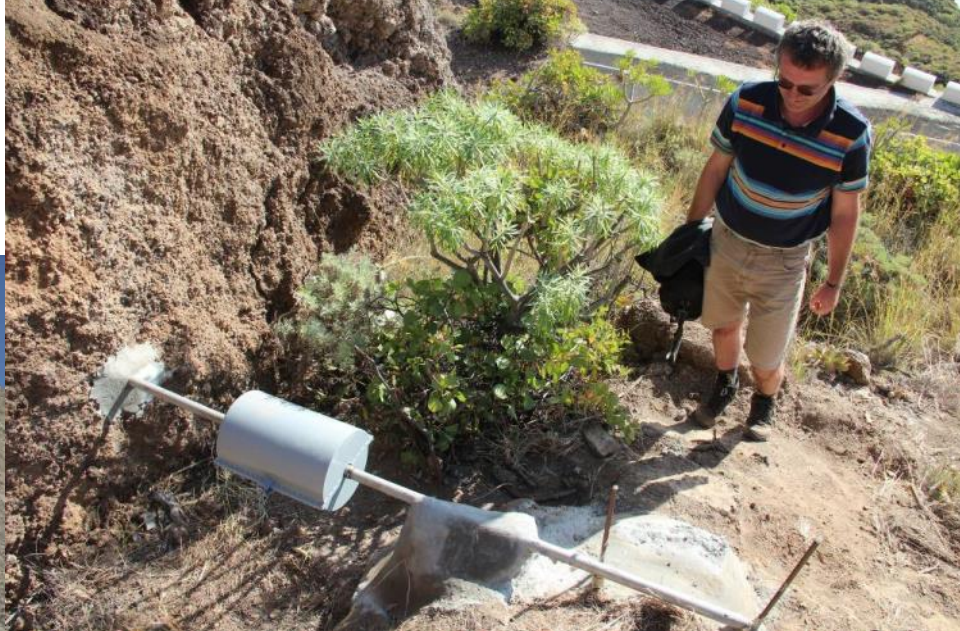
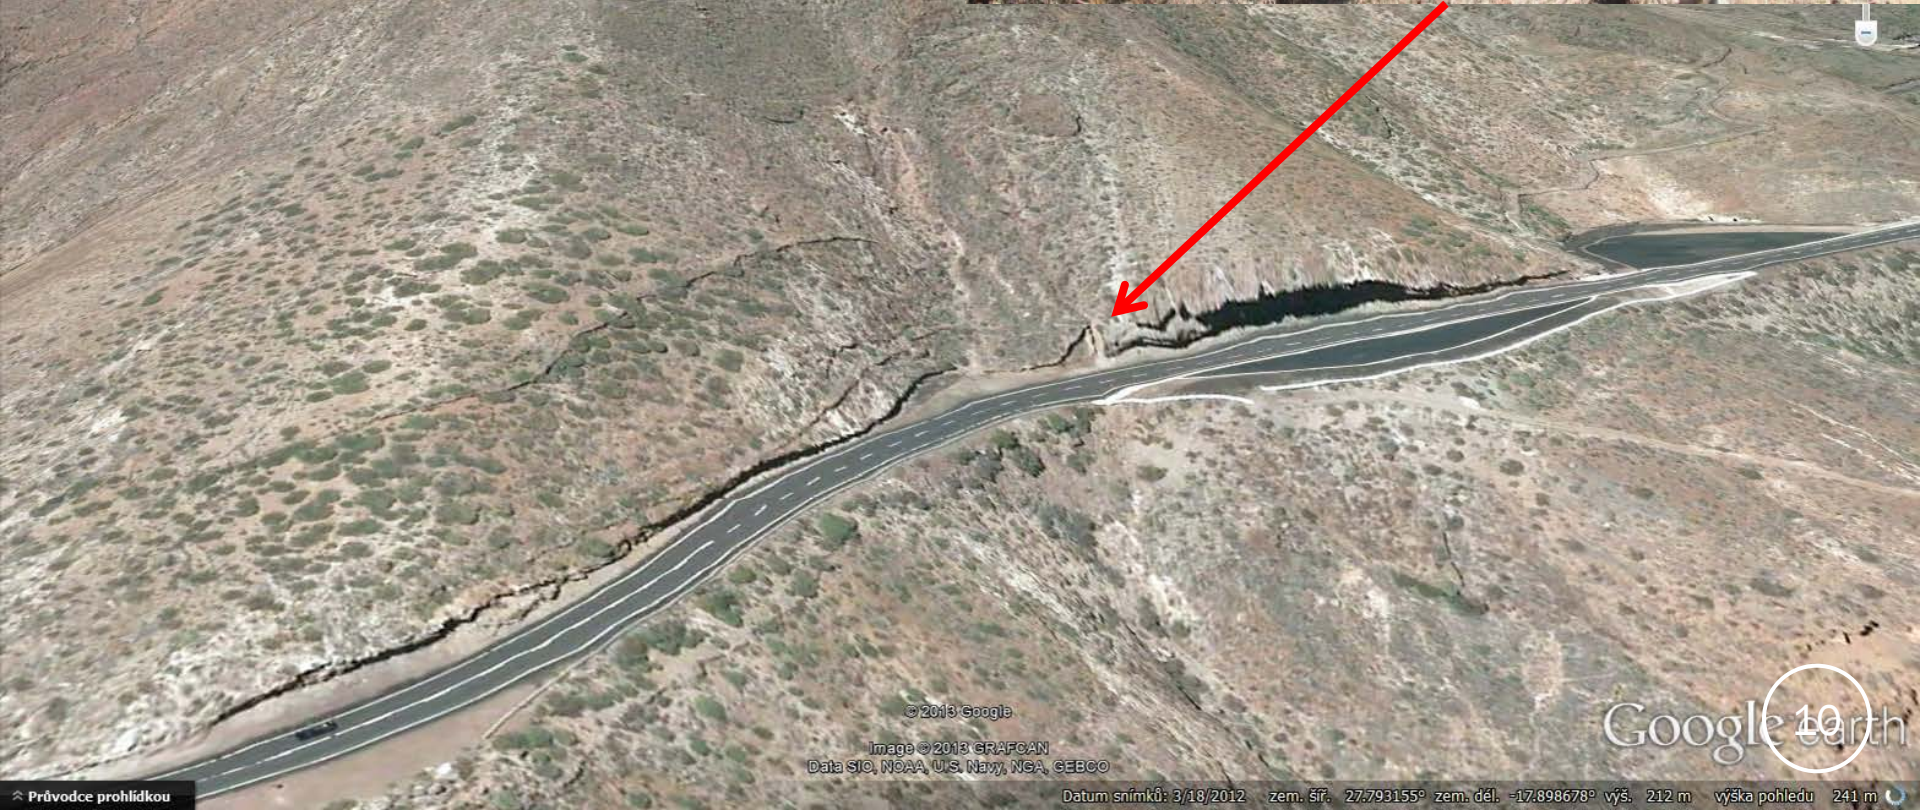
HIE3 MEASUREMENT

- Normal fault $189^{\circ}/81^{\circ}$
- Northern block descended till end of 2013, after that it returned
- By the end of 2013 strong compression followed by seismic activity
- In early 2014 sinistral movement of 0,8 mm with extension
- Nowadays calm – minimum seismicity, reactions on temperature

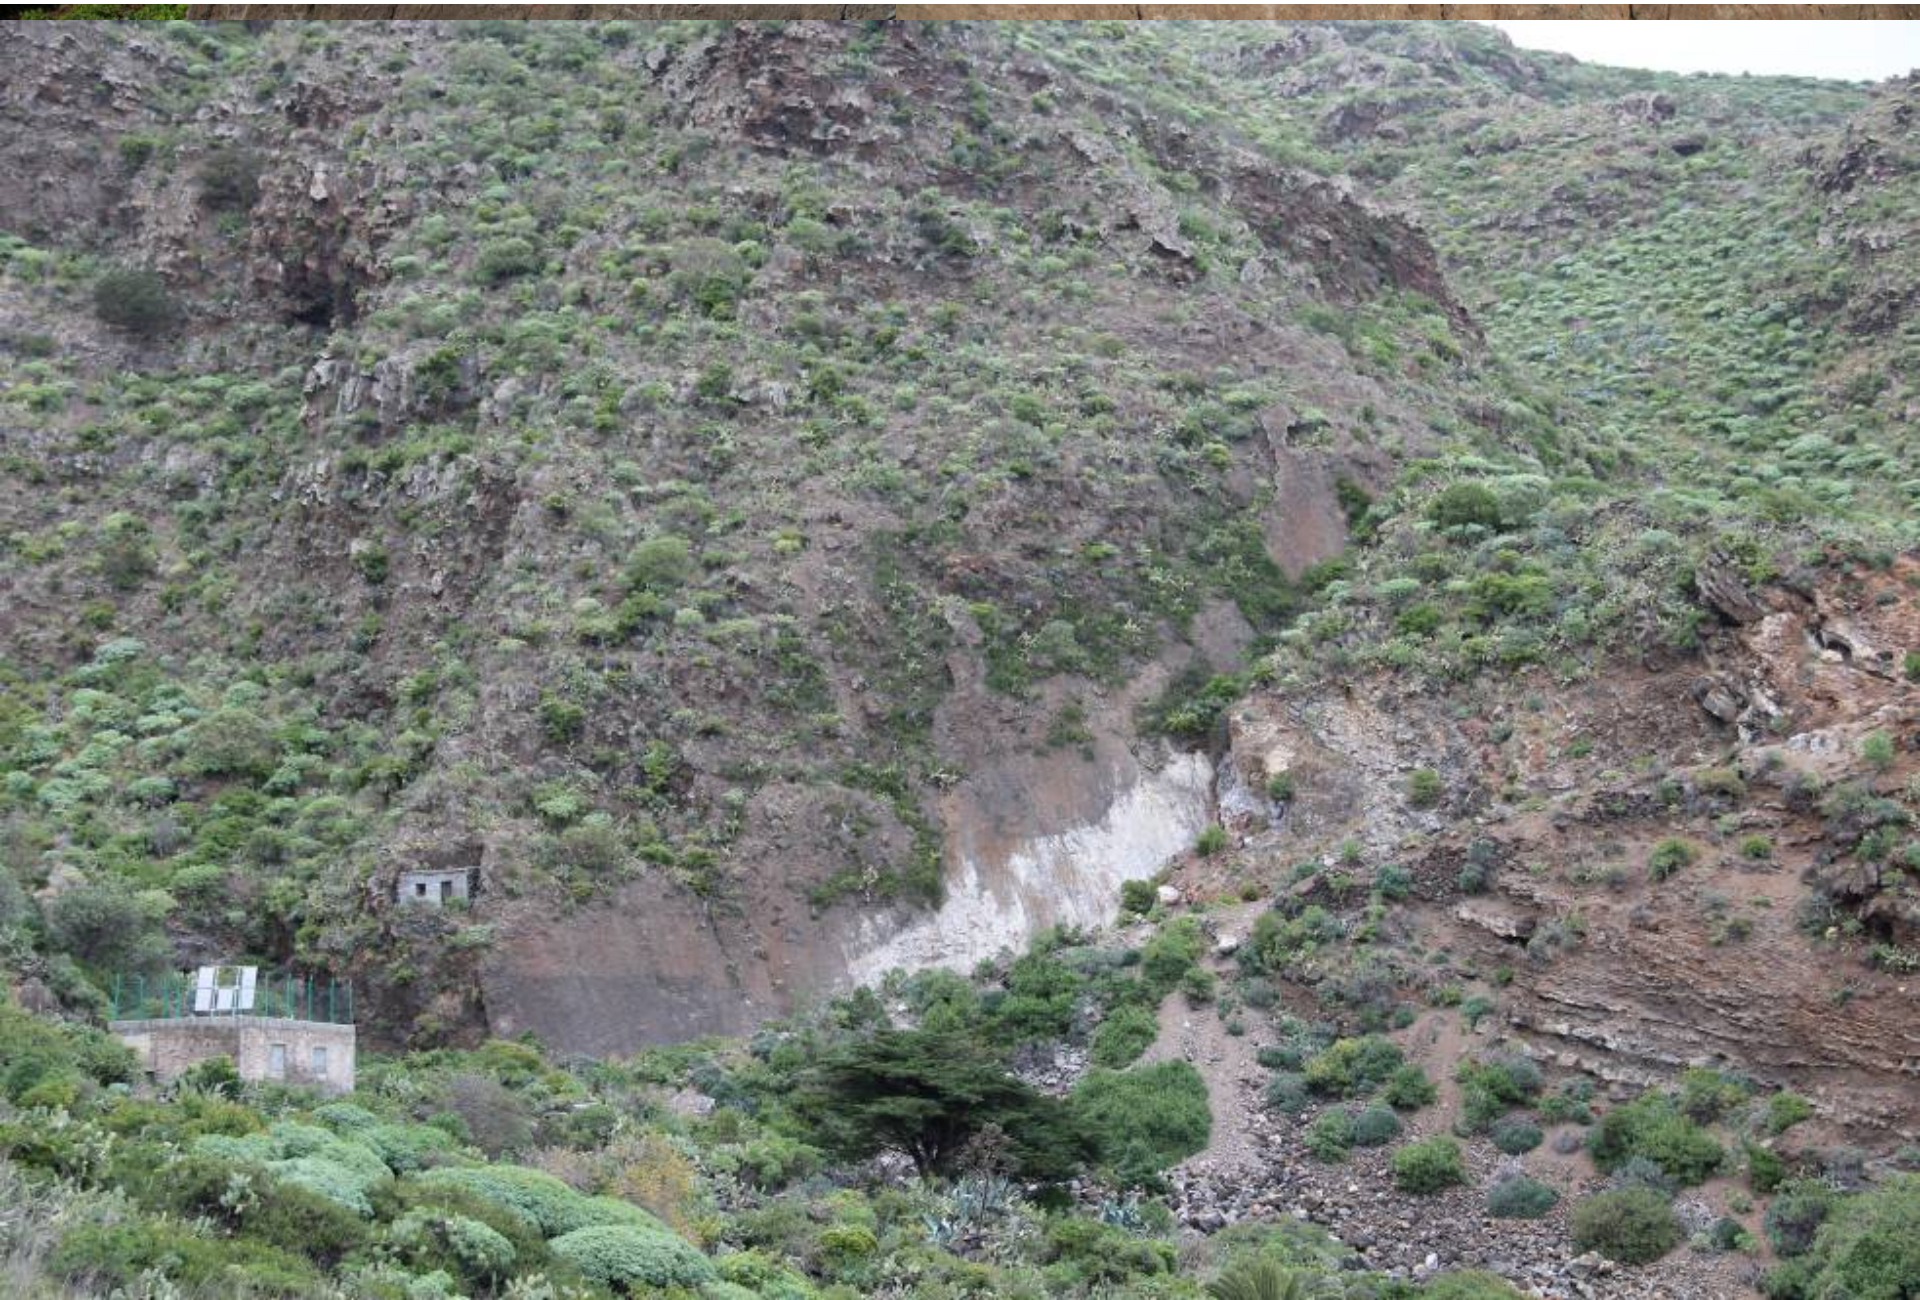
HIE2 MEASUREMENTS

- Normal fault $140^\circ/75^\circ$
- Cyclic compression and extension (temperature)
- Continuous sinistral movement (0,45 mm/4 y)
- Vertical movement since mid 2014 (lower block descending, in 2016 ascended)
- Since 2013 rotation (xy) – opening in NW direction
